ARRAY CONFIGURATION WITH ELEMENT VARIABLE FILTERING

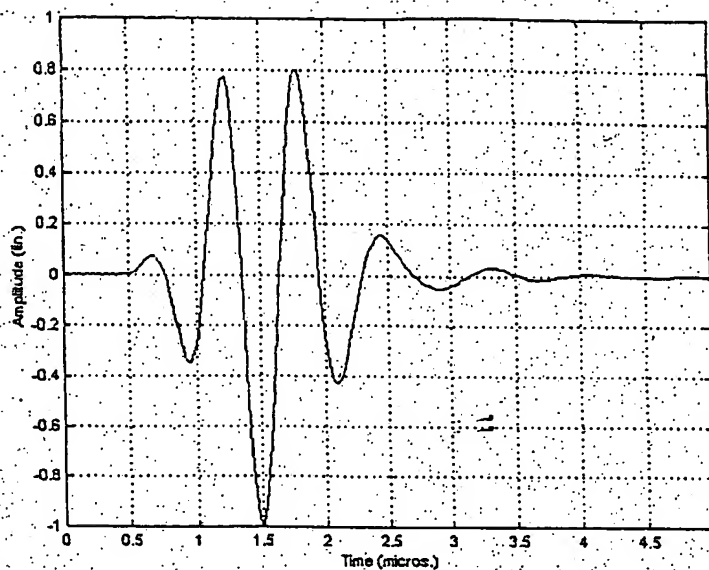
Fig. 7: Received first harmonic signal from the pressure in Fig. 5, when using the response B11 in reception.
